TRANSFORMATIONS

Rehabilitation, Rejuvenation and Tooth Replacement

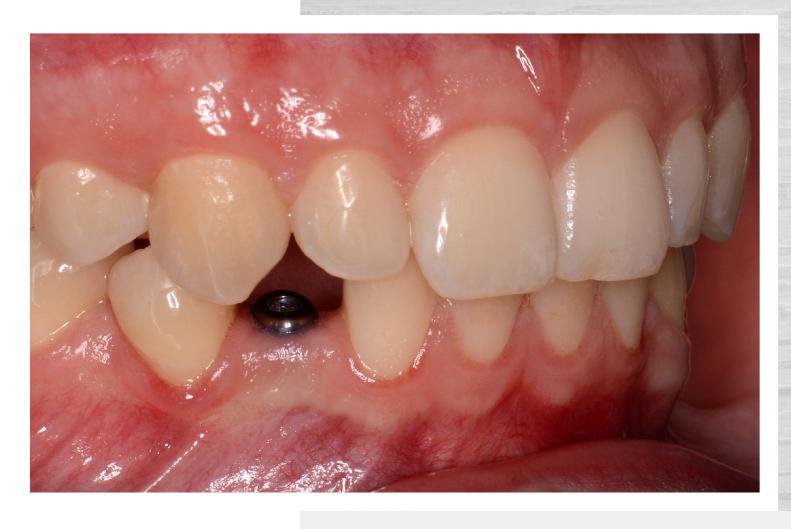
Replacement of Retained Primary Tooth

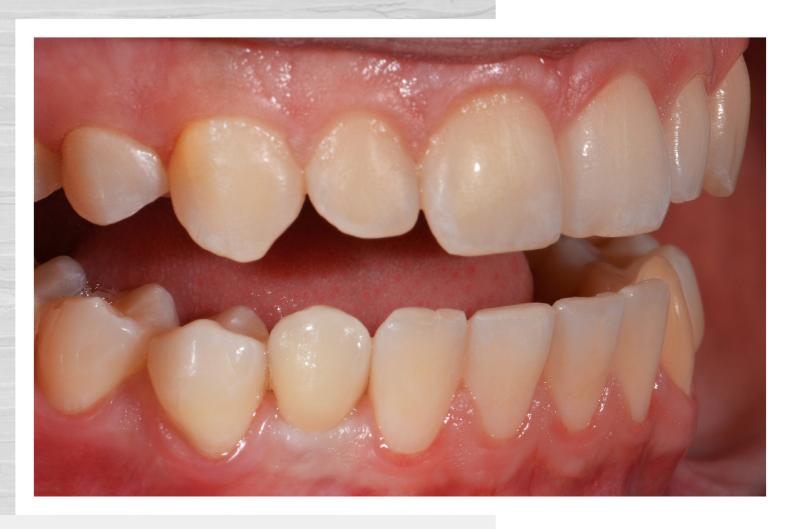
Efforts on multiple fronts allowed us to create this beautiful and esthetic final implant restoration.

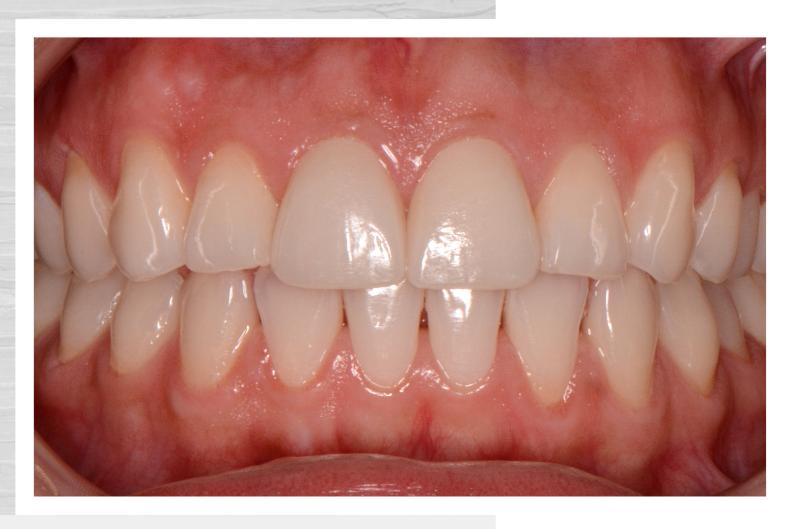
Two perfectly matched final restorations were placed for this patient, and she exuded a new found confidence not previously seen by myself or her friends. This gift is the ultimate reward for a dedicated practitioner; one of the many reasons I am thankful to be able to do something I love each and every day!

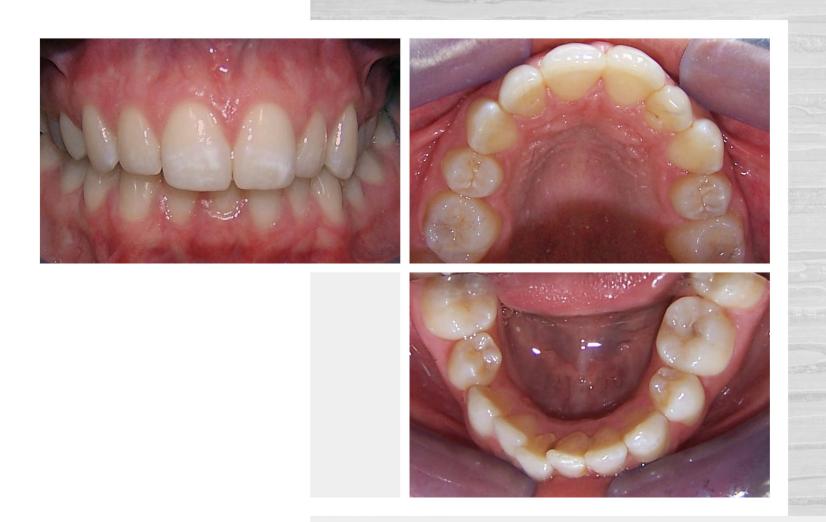
Invisalign Aligner Therapy, Case #1

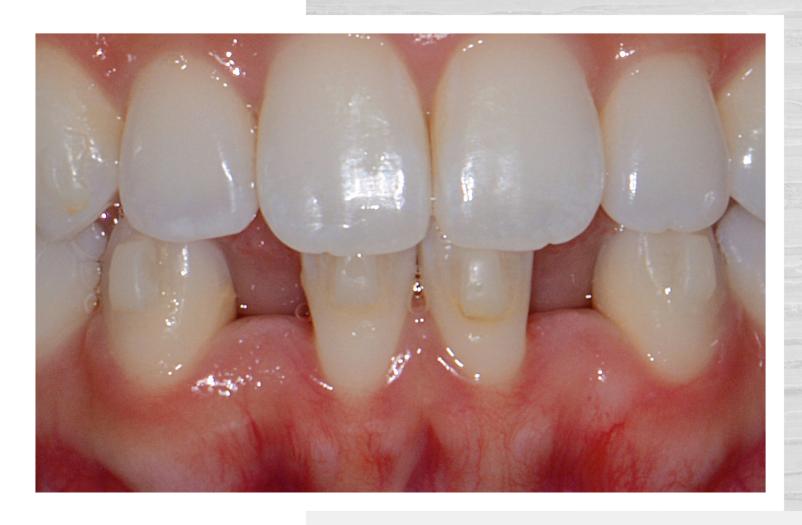
Multidisciplinary Case Approach to replace missing lower lateral incisors

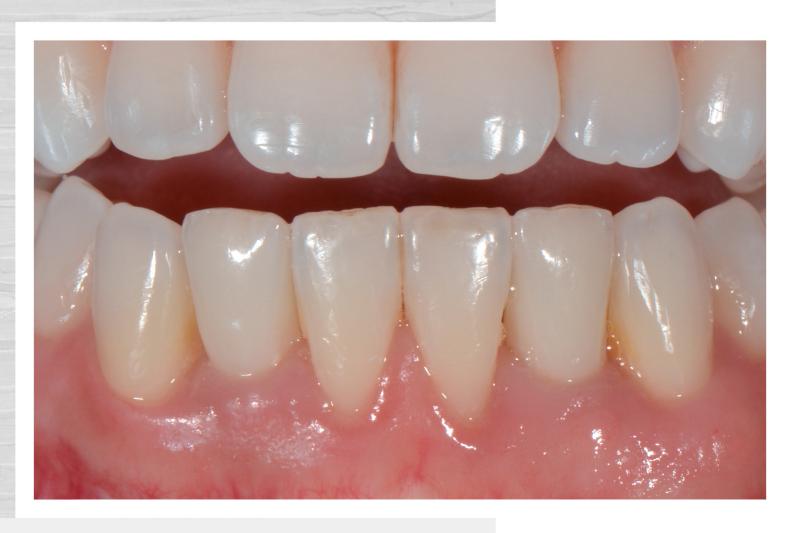
A multi-interdisciplinary approach, with the collaborative efforts of several colleagues, was necessary to achieve this exemplary result.

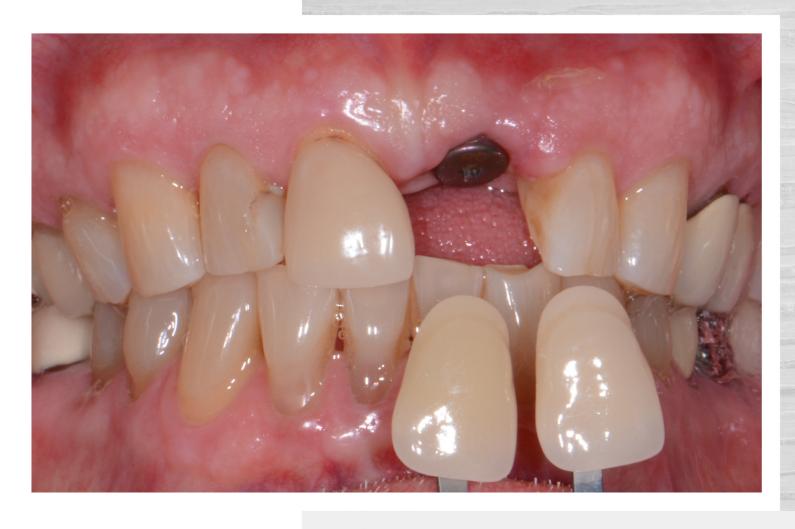
Upper Front Tooth Replacement, Case #1

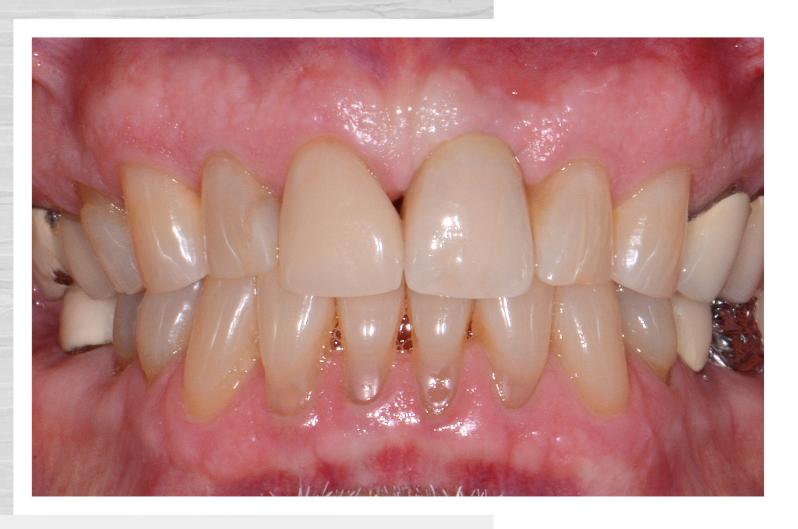
A screw retained provisional restoration was worn for 12 weeks prior to delivering this final implant supported restoration; note the beautiful color match our technician was able to achieve as the final touch to this natural restoration.

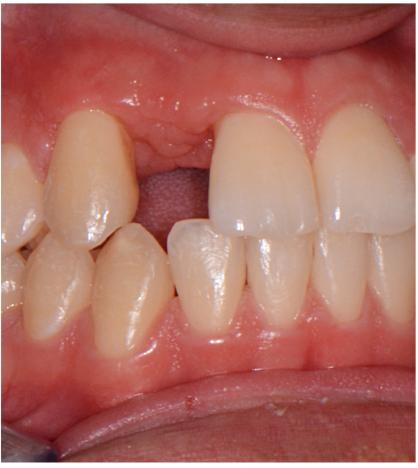
Upper Lateral Tooth Replacement, After Bone Regeneration

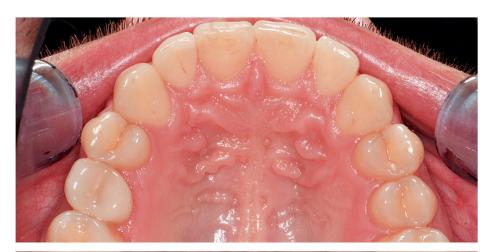
In this pre-treatment image, this patient's upper and lower teeth appear overlapped and crowded. Invisalign aligners were chosen to reposition these crowded teeth.

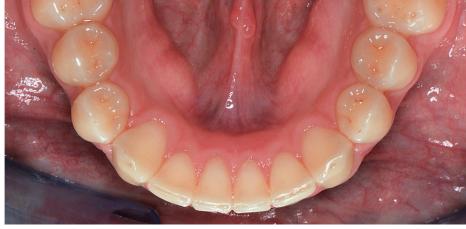
Upon completion, crowding and overlap were eliminated, and a more beautiful smile was evident; consistent night time retainer wear should allow this case to last for years to come.

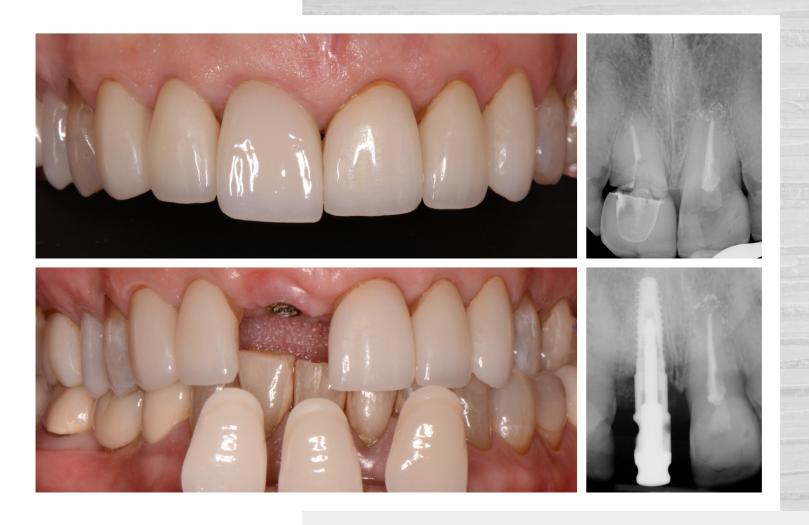
Upper Front Tooth Replacement, Case #2

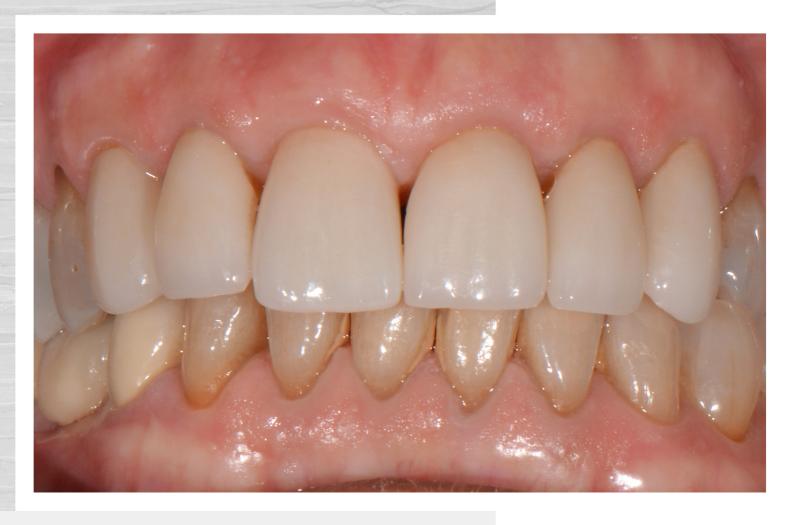
The delivery of this upper front implant supported tooth was the result of patience, proper planning, and execution of perfection during each step along the way. Note how well this final restoration blends with the surrounding teeth, thanks to the artistry and perfection created by our expert lab technician.

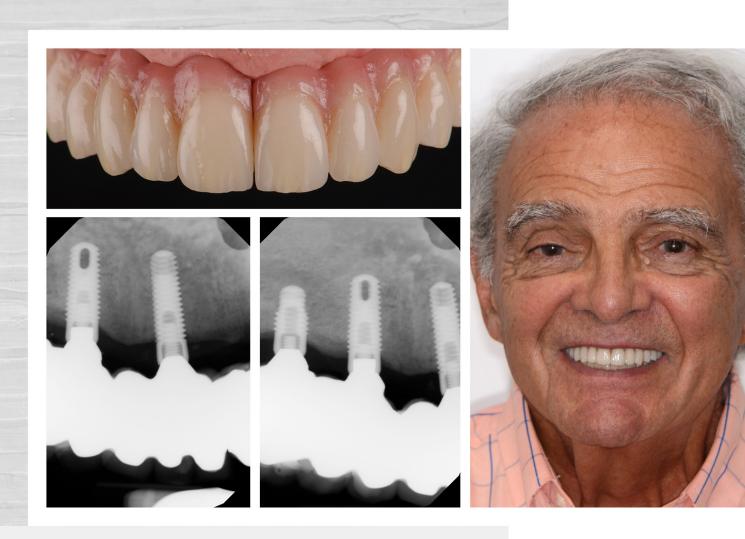
This final restorative picture with radiographic images shows an implant supported solution developed in two segments, replacing not only teeth but also missing gum tissue. Utilizing a Digital Smile Design protocol, this patient will enjoy a beautiful smile for many years to come.

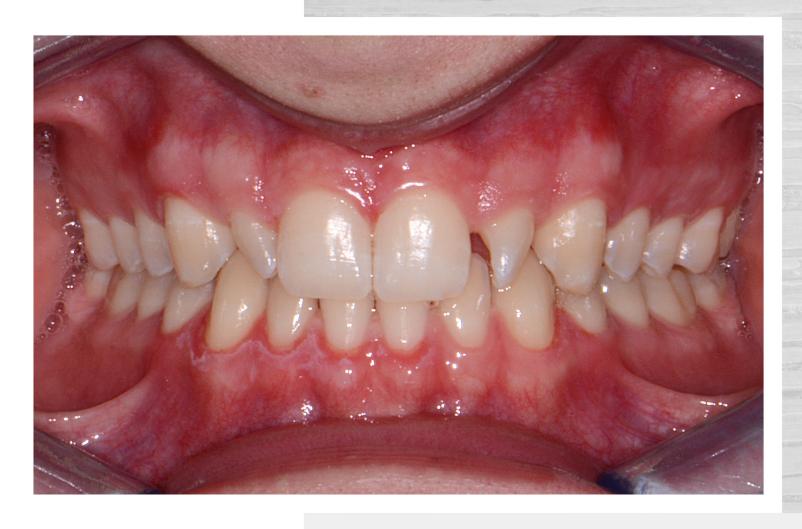
Peg Lateral Conversion to Full Contour Tooth Supported Restorations

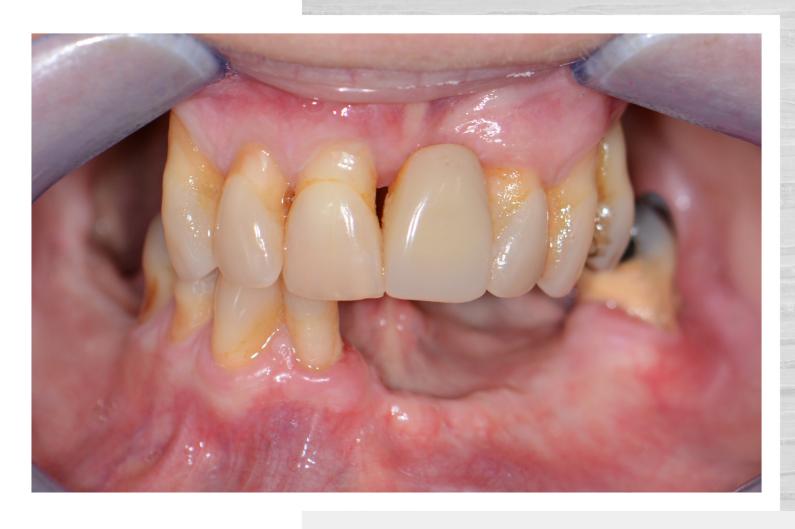
Full Mouth Restoration Upper Hybrid Prosthesis over Implant assisted Lower Complete Denture

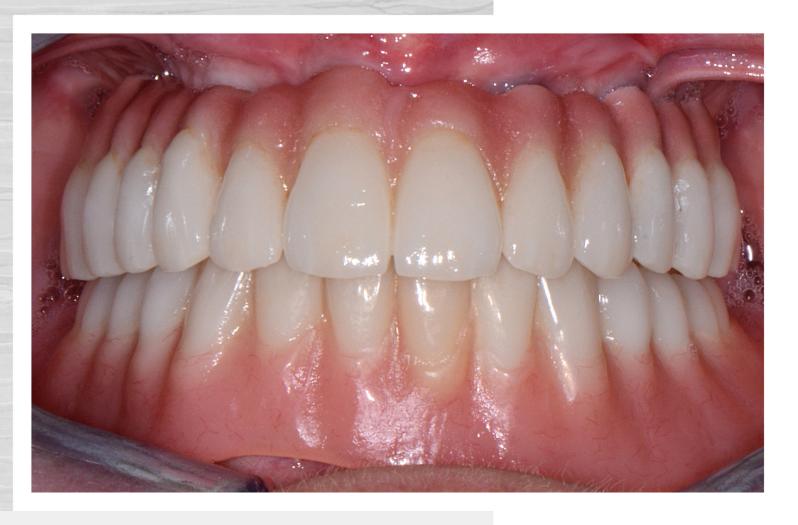
Phase II included placement of six implant fixtures for the upper arch, and two implants for the lower arch. The Upper and Lower dentures were worn during healing for Phase II, and when the implants were integrated, the Upper denture became a prototype for the Upper Fixed Hybrid Prosthesis, while the Lower denture was redeployed and utilized as an Implant assisted denture. Phase III will include the conversion of this implant assisted complete denture to another Implant Supported Hybrid Prosthesis.
